## **Evaluation of Road Pavement Conditions Using The Surface Distress Index (SDI) as A Basis for Determining Maintenance Priorities (Case Study: Guru Bangkol Road, Mataram City)**

Universitas Muhammadiyah Mataram, Indonesia

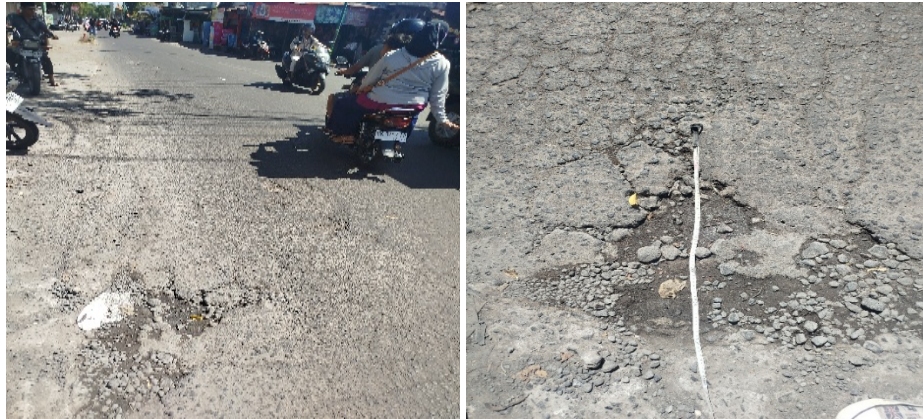
**Figure 4. Condition of Minor Damage**

Field observations show variations in road surface conditions across several survey segments. Field documentation reveals segments in moderate condition characterized by surface cracks and localized damage, as well as segments in good condition that still have a relatively intact pavement surface. This visual documentation supports the classification of road conditions based on SDI values, as shown in Figure 4. Road conditions at STA 0+500 to 0+600 and STA 1+200 to 1+250 are in a state of minor damage.

Technically, the high SDI scores in both segments are due to a combination of larger crack areas, relatively large crack widths, and the presence of potholes in the road surface. The combination of multiple damage types in a single segment causes the accumulated SDI score to increase, shifting the road condition category from good to light damage.

| STA | SDI Value | Condition | Type of Handling |
|---|---|---|---|
| 0+500–0+600 | 115 | Minor Damage | Rehabilitation |
| 1+200–1+250 | 115 | Minor Damage | Rehabilitation |

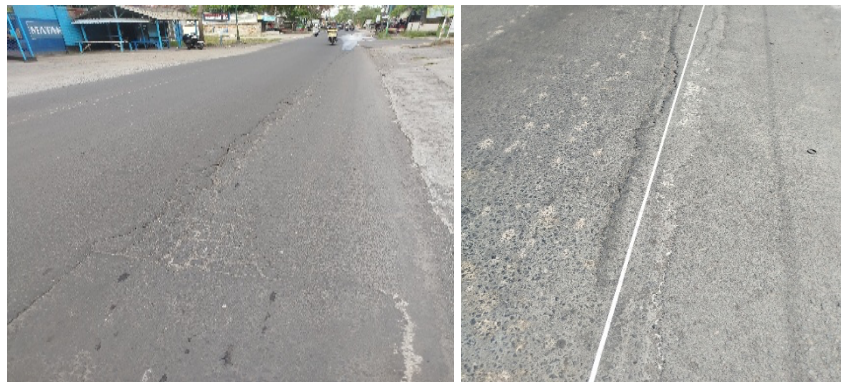
**Figure 5. Moderately Damaged Condition**

Meanwhile, several STAs, such as STAs 0+100 to 0+200, are in moderately damaged condition, as seen in Figure 5 below.

The assessment using the SDI method shows that the most dominant damage on Jalan Guru Bangkol is surface cracks, potholes, and wheel grooves (rutting). These three types of damage are the main parameters in calculating the SDI value and directly affect the classification of road conditions. Based on the survey results, the STA 0+500–0+600 and 1+200–1+250 segments obtained an SDI value of 115, so they are categorized as lightly damaged and recommended for road rehabilitation. Meanwhile, the STA 0+100–0+200 segment obtained an SDI value of 60 which is categorized as moderate and requires regular maintenance.

| STA | SDI Value | Condition | Type of Handling |
|---|---|---|---|
| 0+100–0+200 | 60 | Currently | Periodic Maintenance |

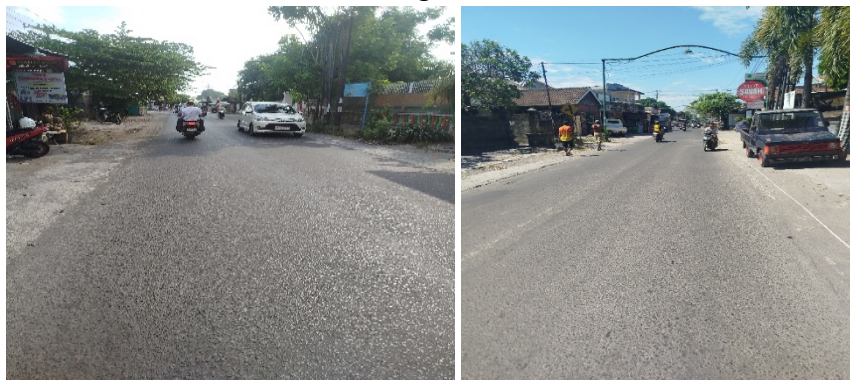
**Figure 6. Good Condition**

However, most of the roads on Jalan Guru Bangkol Mataram are in good condition as seen at STA 0+000 to 0+100, 0+200 to 0+300, 0+300 to 0+400, 0+400 to 0+500 and 0+600 to 0+700 to STA 1+100 to 1+200 as shown in Figure 6 below.
